Manhole Inspection Summary

Manhole # S33A__040MH

Location Address: **520 CENTRE ST**

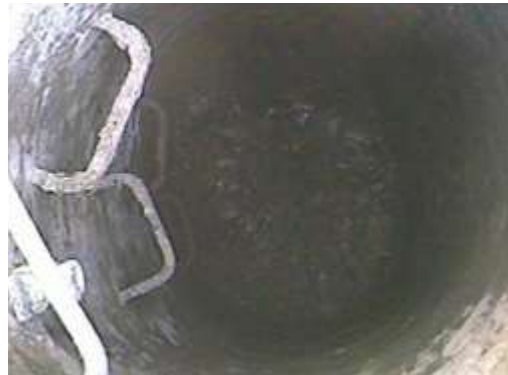
Top View

DEBRIS IN CHANNEL

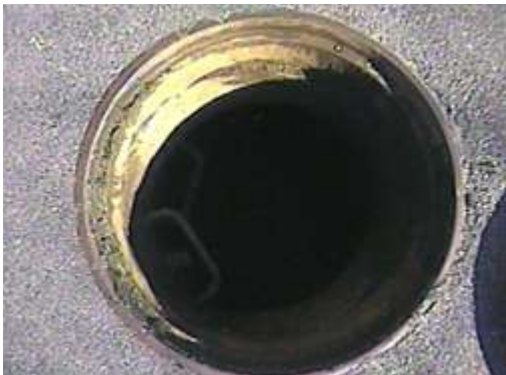
Top View

Offset: **1** (in.)

FRAME OFFSET

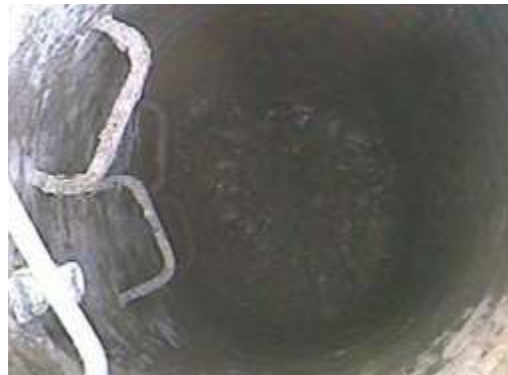
Defect 2

Count: **5** Missing: **0** ☒ **Corroded**

CORRODED STEPS

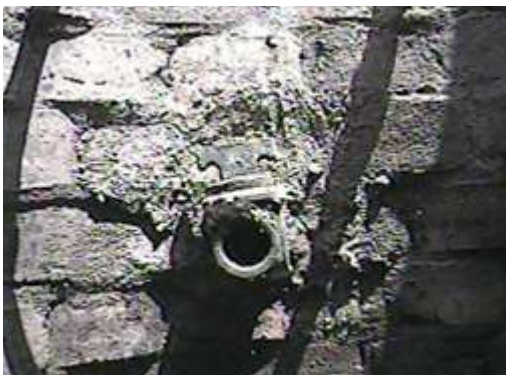
Defect 1

POSSIBLE ILLICIT CONNECTION

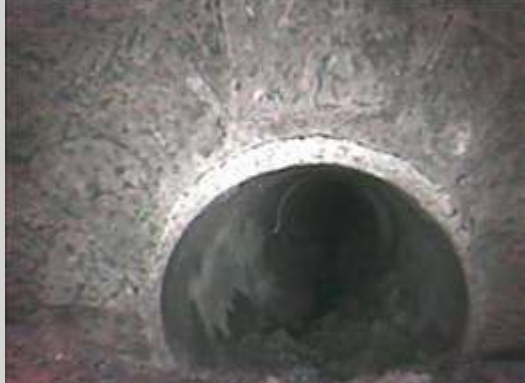
12 O'Clock Outflow

8 in. Circular Gravity Sewer
Pipe Out @ 12 O'Clock

Deposits: ☐ None ☐ Mud ☐ Sludge ☒ **Debris** ☐ Grease

Silt Depth: **2** (in.) Deposits Extent: **Light**
